Reference: Asbestos and Lead-Based Paint Survey Report
SC Dept. of Agriculture Laboratory
1101 Williams Street
Columbia, South Carolina
S&ME Project No. 1614-10-079

ASBESTOS AND LEAD-BASED
PAINT SURVEY REPORT

**SC DEPT. OF AGRICULTURE LABORATORY
1101 WILLIAMS STREET
COLUMBIA, SOUTH CAROLINA**

S&ME Project No. 1614-10-079

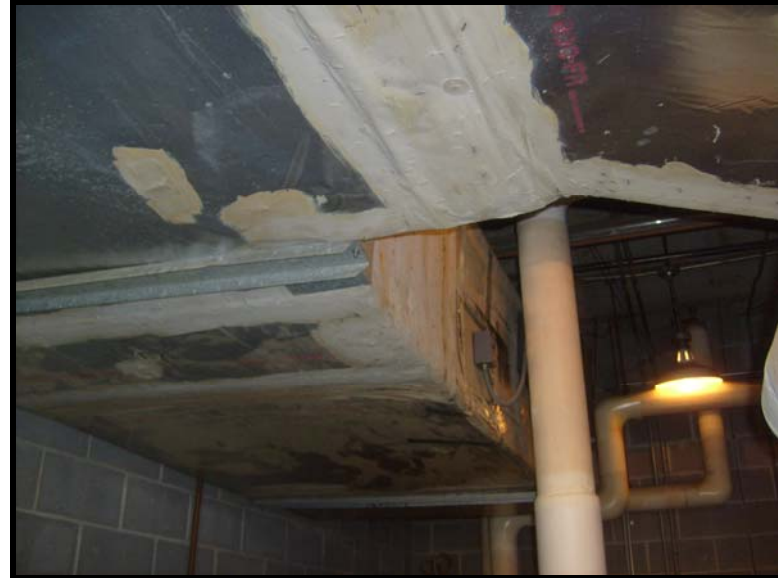
- *Grey duct insulation sealant* (25-35% chrysotile) located on the seams in the fiberglass insulation on the HVAC ductwork. Refer to Photographs 2 and 7. The positive samples were collected from ducts in the northeast mechanical room. Approximately 250 linear feet observed. This estimate is subject to change following the removal of the suspended ceilings to expose the entire duct system.

2 The white/grey sealant on the HVAC ducts in the northeast mechanical room tested positive for asbestos (25-35% chrysotile).

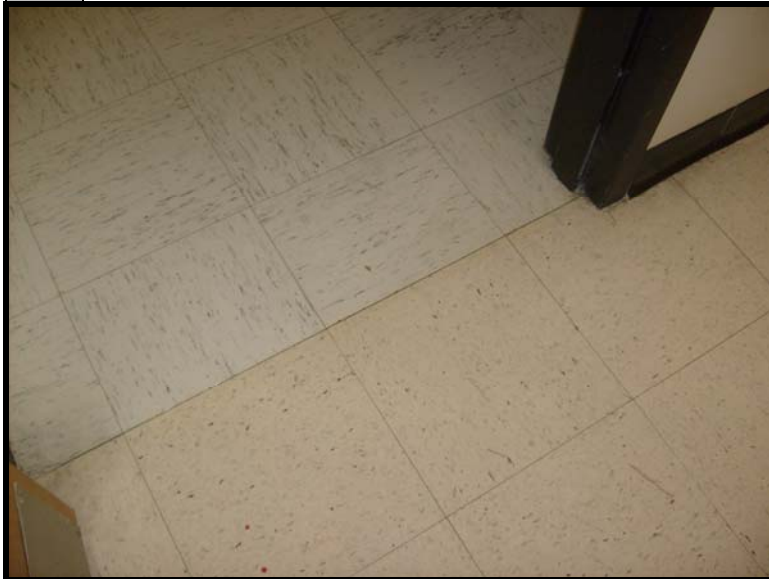
3 The two predominant types of 12" floor tile in the building. The lighter tiles are located on the 2nd floor, the beige ones are on the 1st floor. Both tiles and associated mastics contain asbestos.

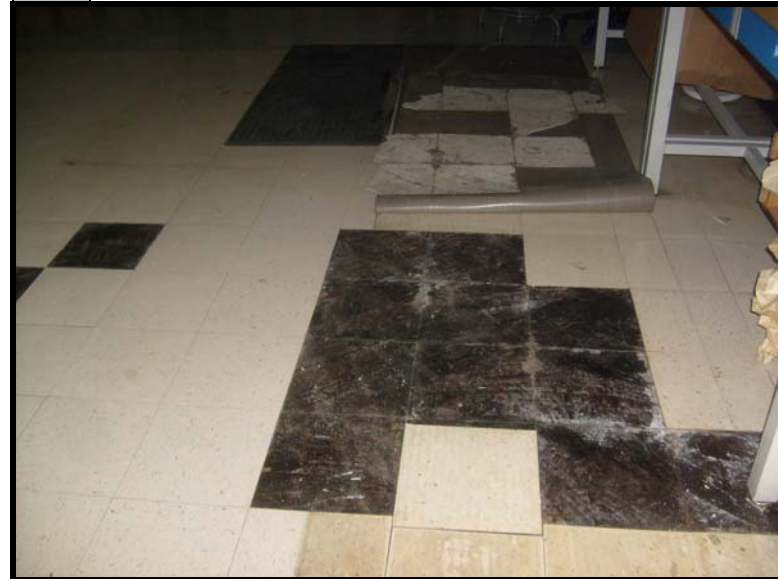
4 Damaged ACM floor tiles in the Petroleum Lab on the first floor. The asbestos-containing black mastic is exposed.

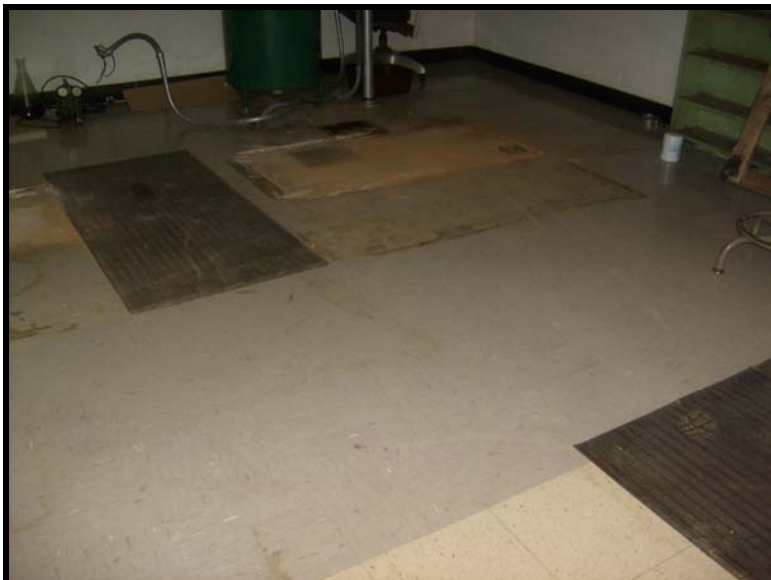
The TEM analysis confirmed that no asbestos is present in the samples at concentrations $\geq 1\%$. However, materials that are bound to confirmed ACM (i.e. grey 12-inch floor tiles in the Petroleum Lab that are bound to the asbestos-containing mastic) should be considered to be ACM.

5 Grey 12-inch floor tiles in the Petroleum Lab on the first floor. The tiles do not contain asbestos; however, the mastic is <1-4% chrysotile. Consequently, the tiles are considered ACM.

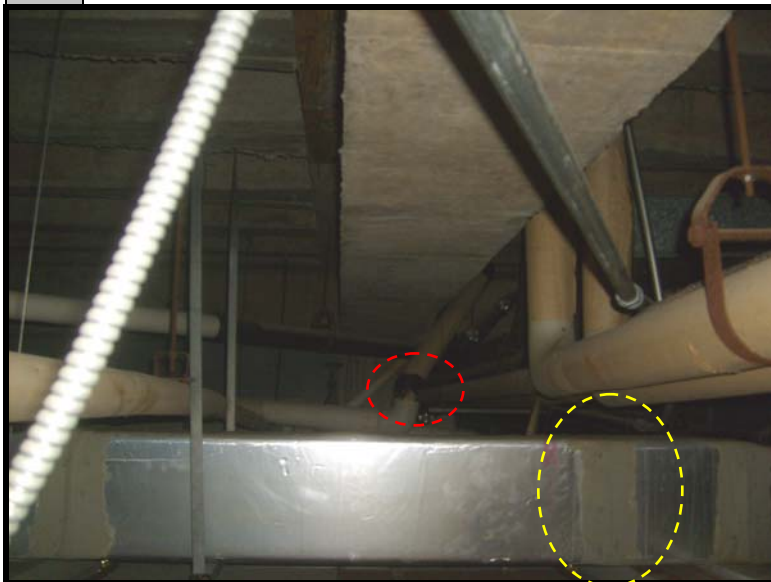
- *Joint compound* (2% chrysotile) associated with the drywall wall systems on the second floor. Approximately 30,000 square feet of drywall.
- *Bituminous pipe insulation sealant* (5% chrysotile) located on the seams of the fiberglass insulation on the water pipes above the suspended ceilings on the first floor. Refer to Photograph 7. The bituminous sealant was observed in the central portion of the building above the suspended ceilings and exposed in the room that contains the elevator equipment room. Approximately 100 linear feet of pipe were observed. This estimate is subject to change following the removal of the suspended ceilings to expose the entire piping system.

7 Grey duct sealant (yellow circle, 25-35% chrysotile) and black pipe insulation sealant (red circle, 5% chrysotile) located above the suspended ceiling in the Conference room on the first floor.

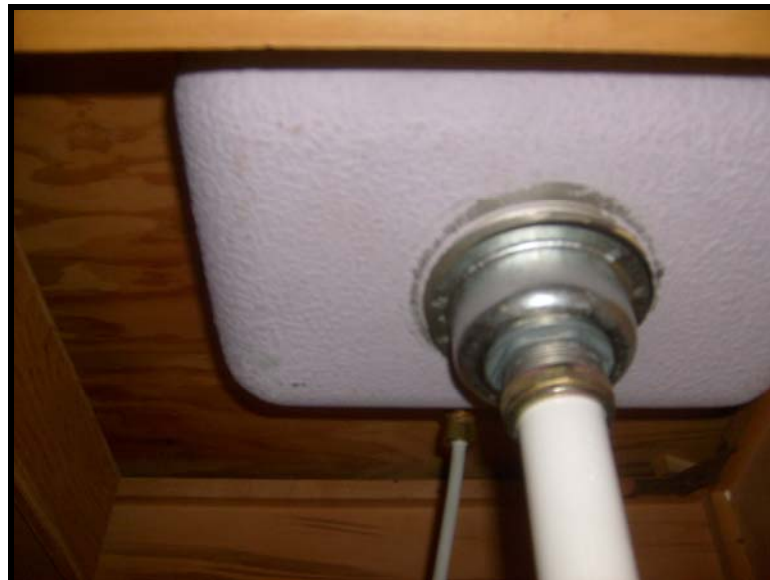
- *Purple soundproofing* (2% chrysotile) on the bottom of the metal sink in the break room on the second floor - Refer to Photograph 6. One sink was noted.

6 The purple soundproofing on the bottom of the metal sink in the break room on the second floor contains 2% chrysotile.

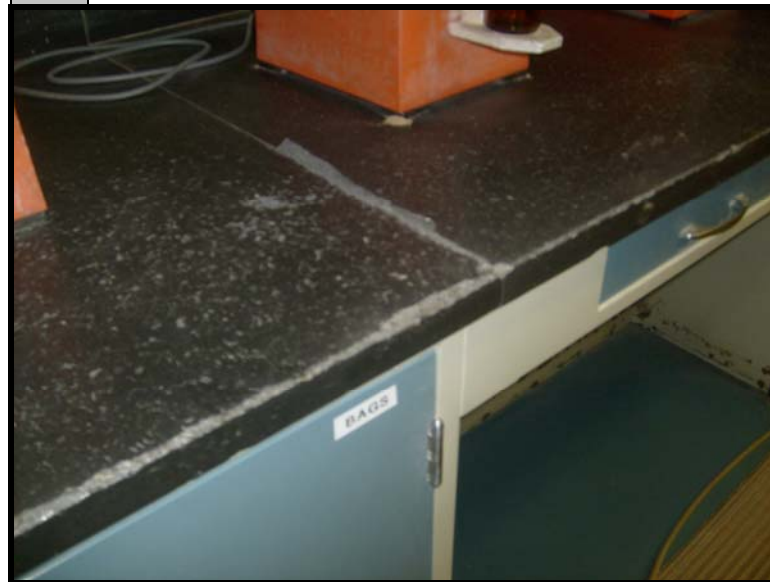
8 The black laboratory benches on the second floor tested positive for asbestos (15% chrysotile). This is the bench where sample "LB-1" was collected.

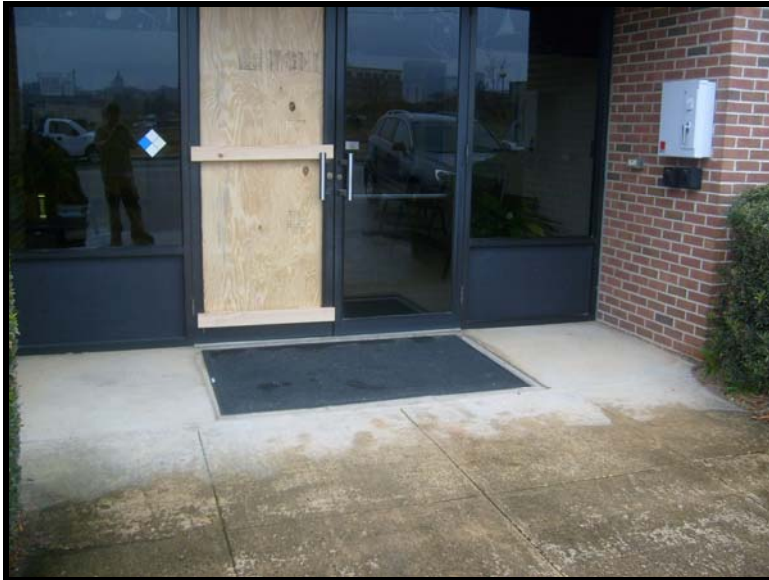
9 The cementitious panels beneath the windows on the first floor are assumed to contain asbestos.

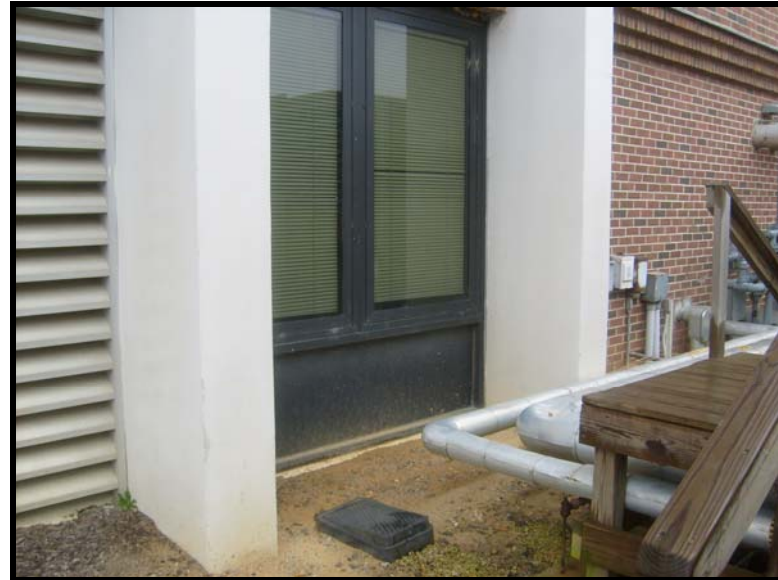
10 The cementitious panels beneath the windows on the first floor are assumed to contain asbestos.
